Technical Report CHL-97-5
March 1997

Monitoring Completed Navigation Projects Program

Burns Harbor, Indiana, Monitoring Study

Volume I: Overview of Approach and Results

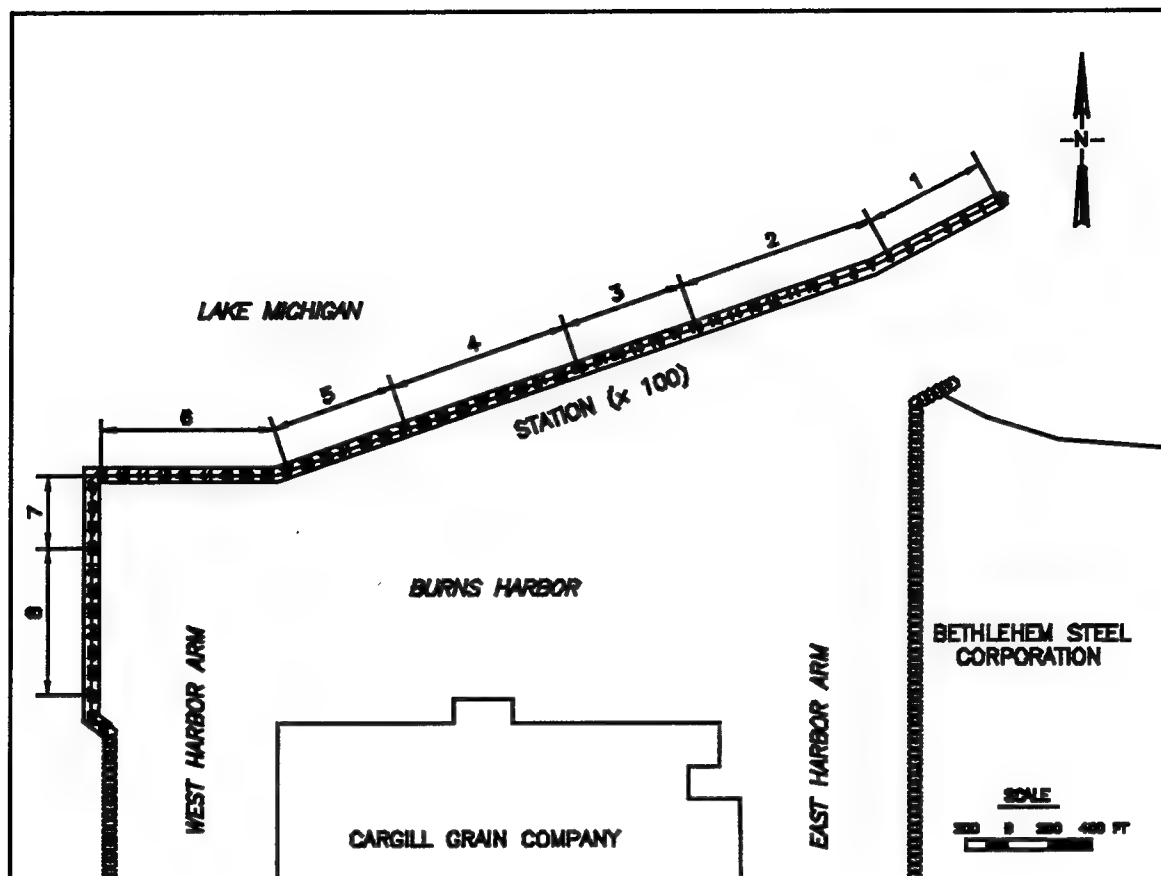
Figure 16. Breakwater segments

Of the four possible breakwater responses, trend 2 is assumed to represent the worst-case scenario for breakwater damage. Conversely, the most desirable breakwater response would be trend 3. According to differences between the 1967, 1975, and 1989(92) surveys, breakwater segments 5 and 8 have experienced a trend 2 response. Segments 1, 3, and 4 show trend 3 response. Only segment 7 shows a trend 1 response, with segment 2 showing a trend 4 response. Segment 6 shows no significant change with respect to mean cross-sectional area or variance between 1975 and 1989, despite 17,600 tons of stone being placed on that portion of the breakwater for the same time period.

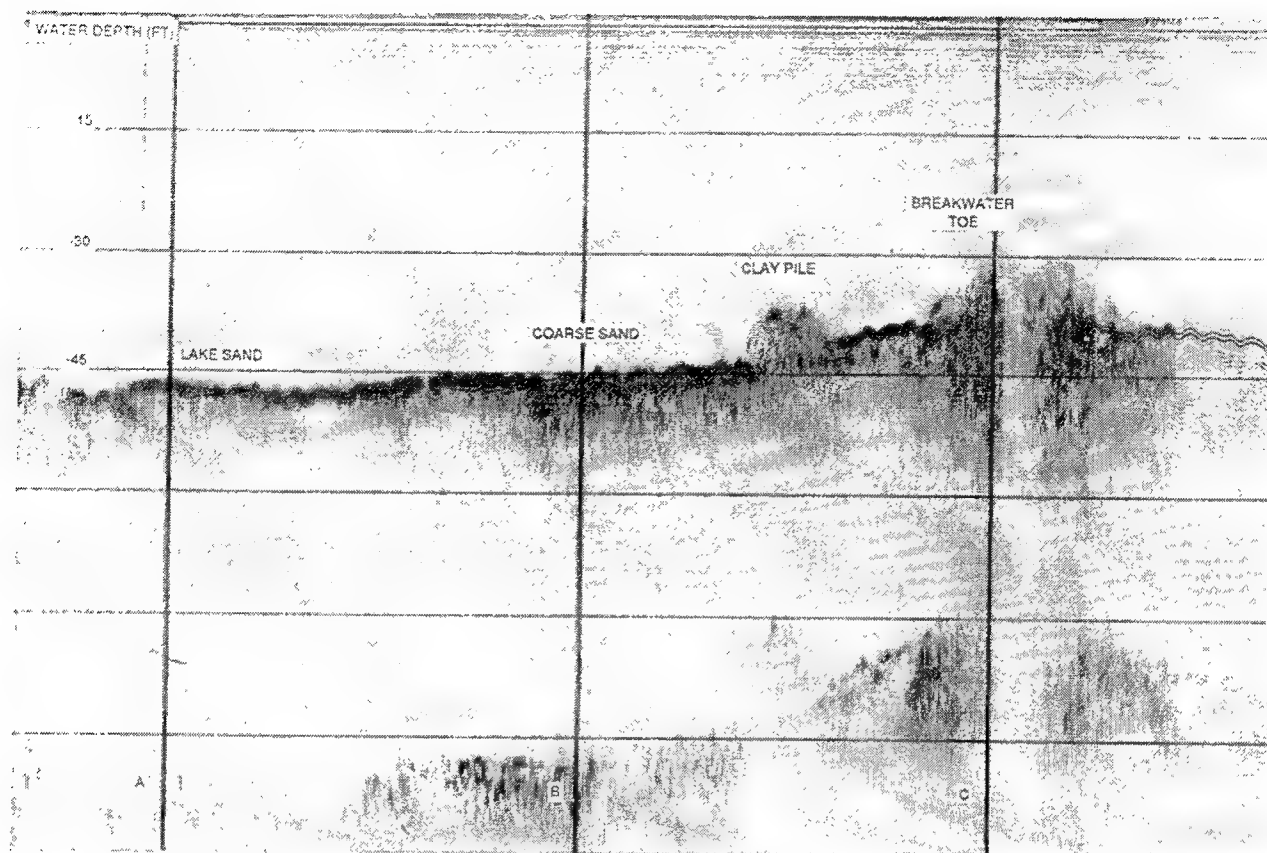
Figure 22. Subbottom sonar sonogram, line 25L

Subbottom sonar surveys. Track lines 16L, 25L, and 33L are shown on Figure 18 with hash marks labelled at corresponding fix marks (A, B, C,...) on the SBS sonograms to identify the features. Figure 22 is the sonogram of line 25L. The shallow relief of the coarse sand deposit, the abrupt outline of the clay mound, and the beginning of the breakwater slope are easily identifiable. Some layering is discernible in the sediments away from the structure.

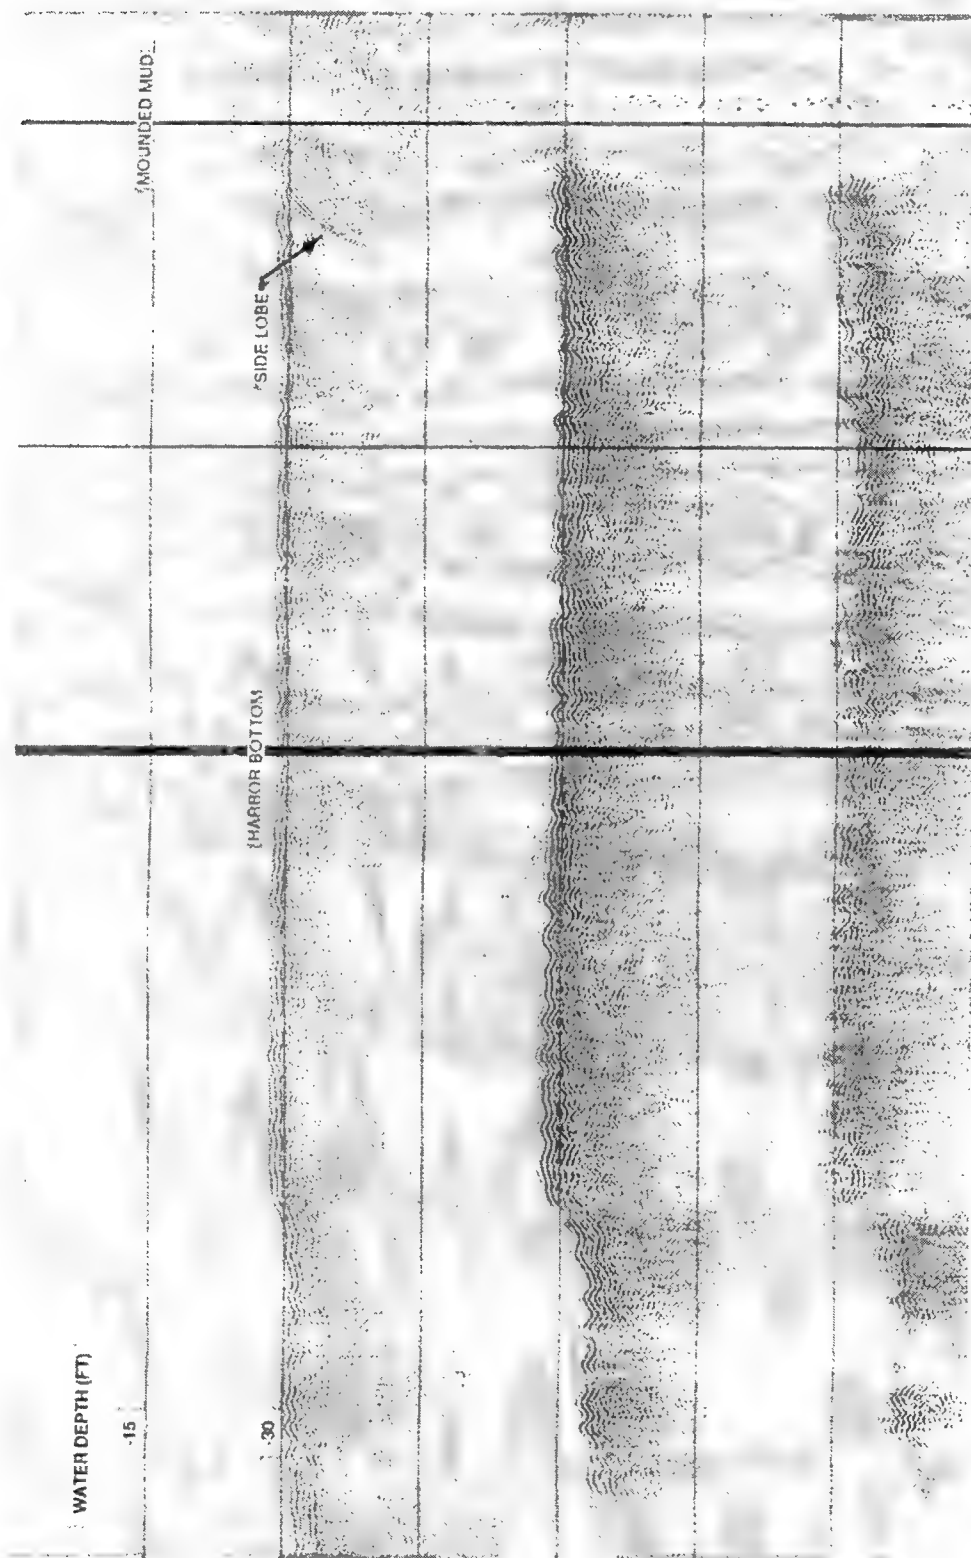
Figure 23. Subbottom sonar sonogram, line 35H

On the harborside, the SBS confirms the featureless bottom seen on the SSS sonogram. Figure 23 is the line 35H. The faint return from the soft clay as it slopes upward to about -20 ft is barely visible at the right end. Its shape is inconsistent with sedimentation due to material settling from above. There is no evidence of a distinct hard return as would be caused by armor stone below this slope. The curved reflection labeled "sidelobe" comes from strong reflections from the armor off to the side of the transducer as it approaches the structure.

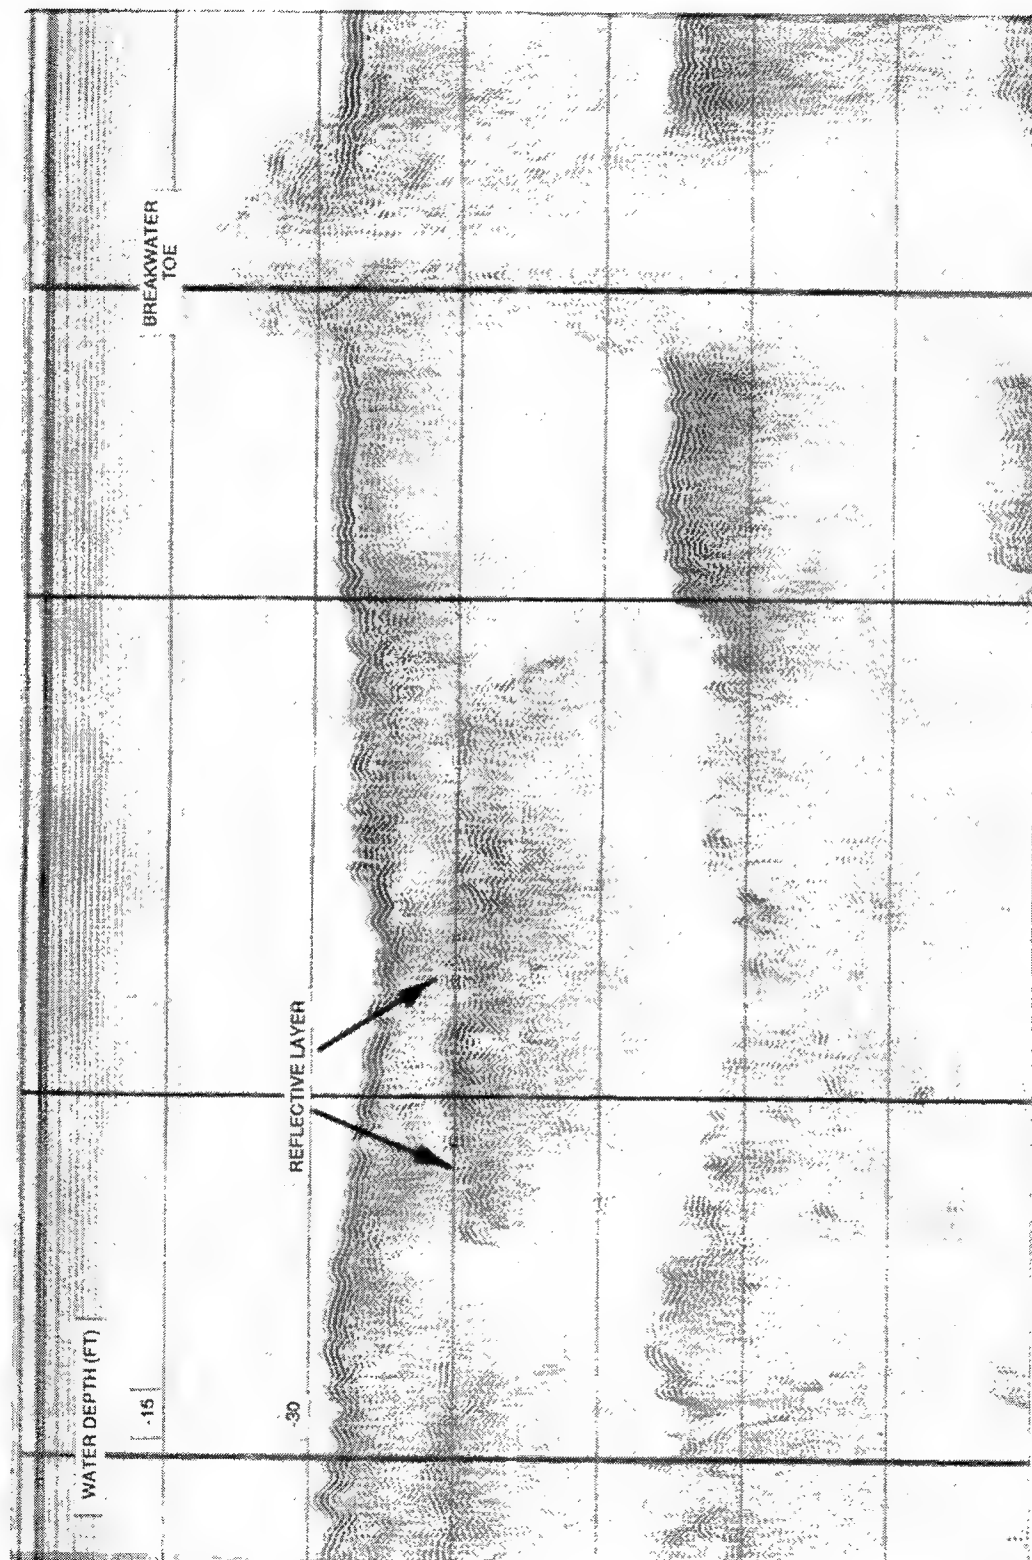
Figure 24. Subbottom sonar sonogram, line 6H

In contrast, line 6H (Figure 24), which traverses the entrance channel, indicates a harder layer 7-10 ft below the lake bottom, or at -45 ft. Approaching
